# Decades-Long Impact of Topsoil Removal

November 7, 2023

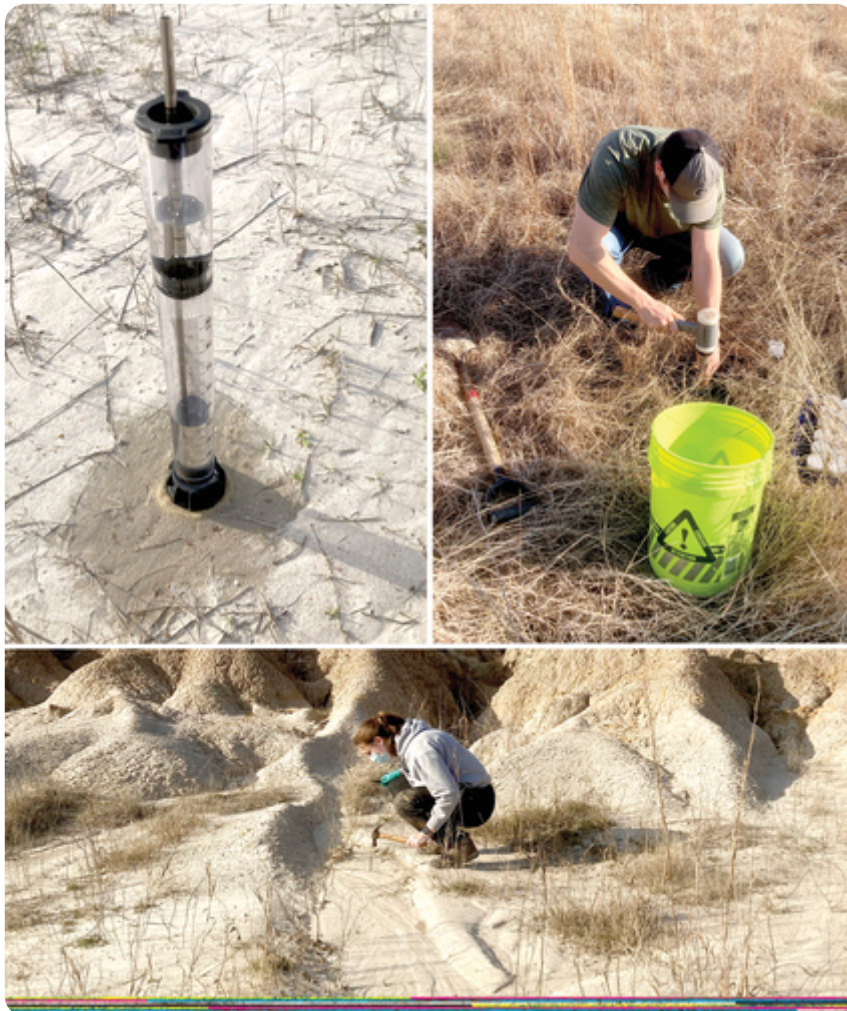
*Clockwise from top: A mini disk infiltrometer measures infiltration of water into soil in the disturbed area, Texas A&M University graduate student Parker Murphree collects soil*

*samples to determine soil texture, and Texas A&M University graduate student Stephanie DeVilleneuve measures soil erosion in an area where a large amount of soil was previously removed. Photos by Briana Wyatt.*
